CORNELL-DUBILIER ELECTRONICS SITE

REVISED REMOVAL ACTION REPORT

DECEMBER 2009

Region II Removal Support Team 2, Weston Solutions, Inc. Edison, New Jersey 08837

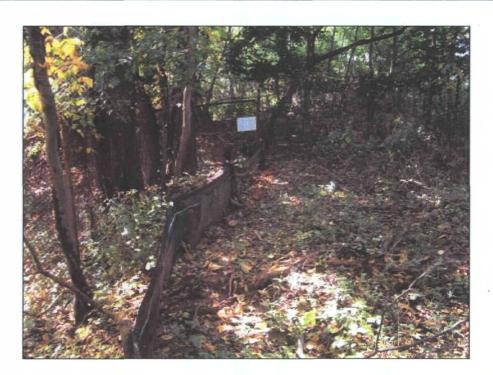
Picture 1: Southeastern corner of the Site prior to grubbing (October 14, 2008).

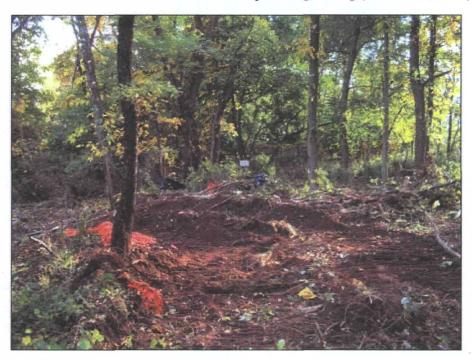
Picture 2: Southeastern corner of the Site during grubbing (October 14, 2008).

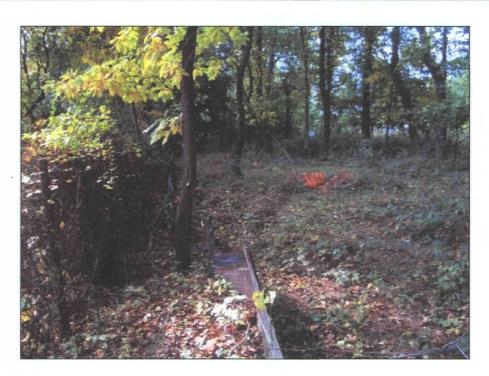
Picture 3: Area adjacent to the fence bordering the wetlands prior to grubbing (October 14, 2008).

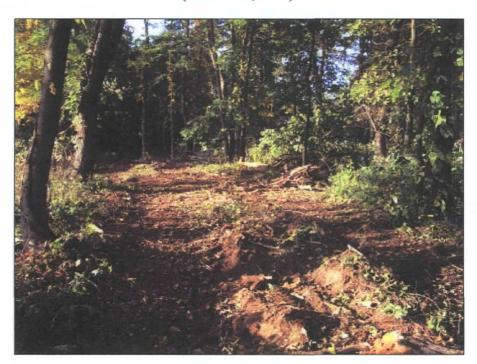
Picture 4: Area adjacent to the fence bordering the wetlands following grubbing (October 14, 2008).

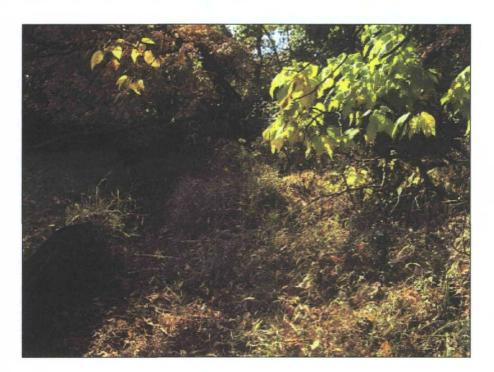
Picture 5: Slope bordering the wetlands at the southeastern corner of the Site prior to grubbing (October 14, 2008).

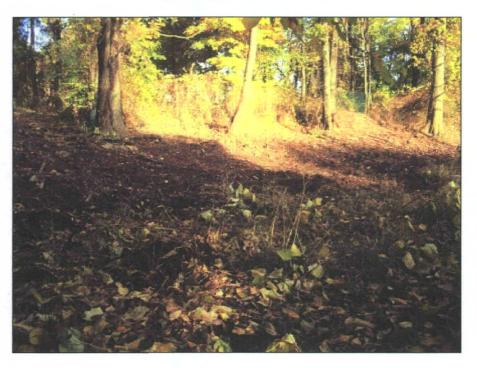
Picture 6: Slope bordering the wetlands at the southeastern corner of the Site following grubbing (October 15, 2008).

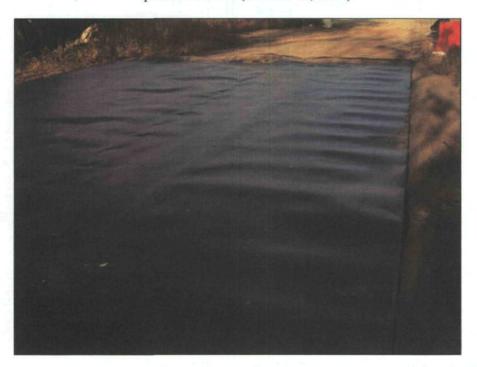
Picture 8: Poly sheeting placed over crushed stone base in the Stone Staging Area (October 15, 2008).

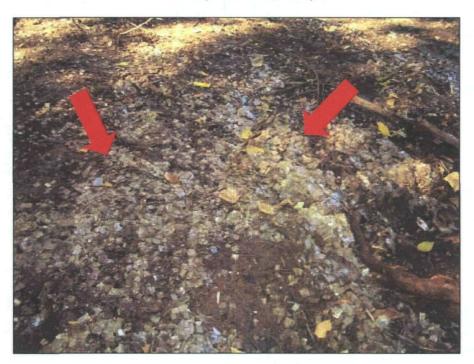
Picture 10: Capacitor film uncovered near the southwest corner of the Site (October 15, 2008).

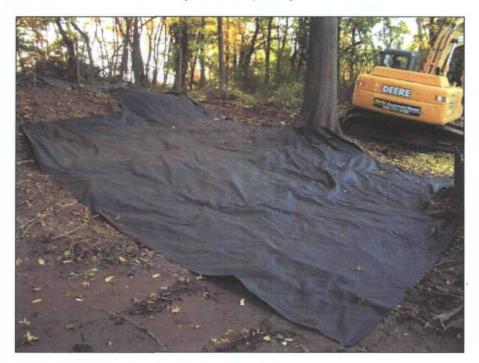
Picture 12: Geotextile material installed on the stream bank adjacent to the wetlands perimeter fence (October 15, 2008).

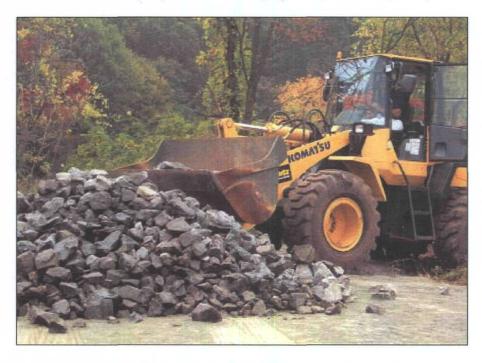
Picture 14: ERRS transferring rip-rap with a front end loader (October 16, 2008).

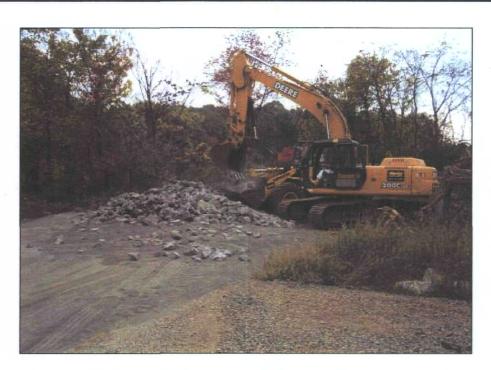
Picture 15: ERRS transferring rip-rap with an excavator (October 16, 2008).

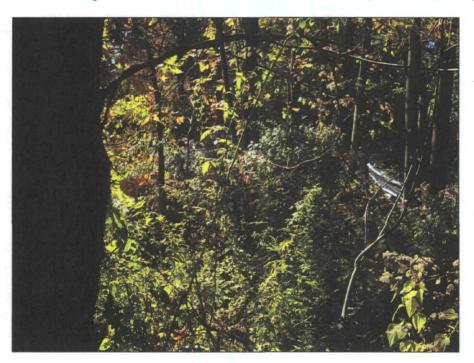
Picture 22: Stream bank at the edge of wetland area, viewed from the North prior to grubbing (October 20, 2008).

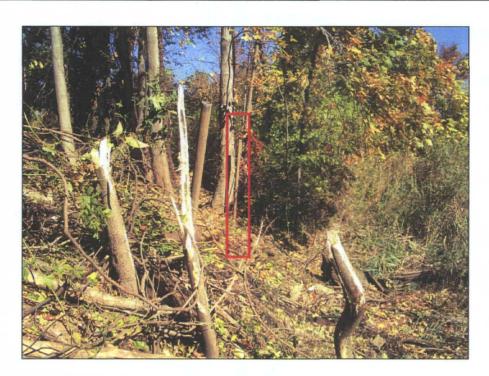
Picture 23: Stream bank at the edge of the wetlands area viewed from the South during grubbing. Box indicated final fence post in existing fence (October 20, 2008).

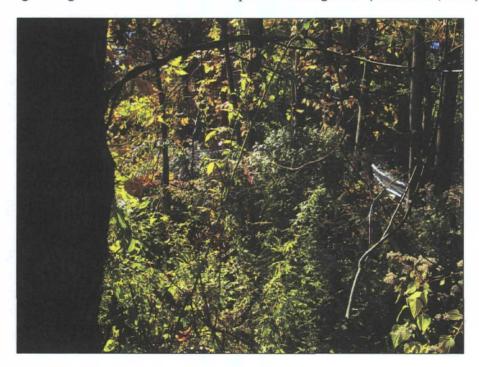
Picture 24: Bank at the edge of the wetlands area viewed from the North prior to grubbing (October 20, 2008).

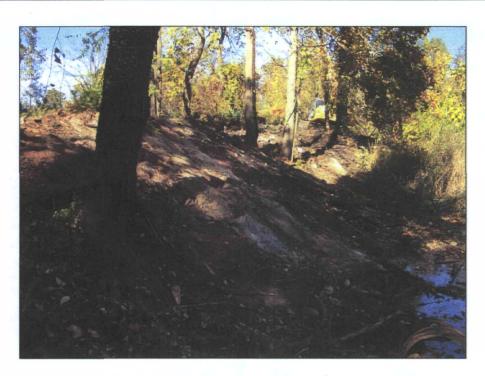
Picture 25: Bank at the edge of the wetlands area viewed from the South after grubbing. (October 20, 2008).

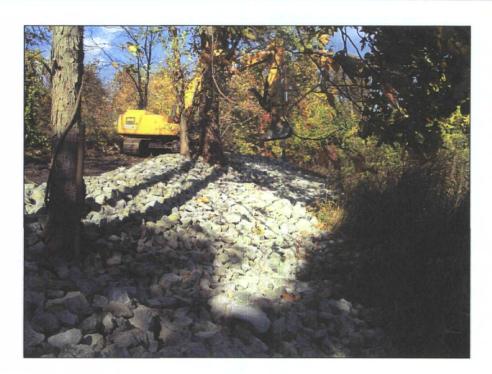
Picture 29: Bank approximately 150 feet South of the twin culvert with rip-rap installed (October 21, 2008).

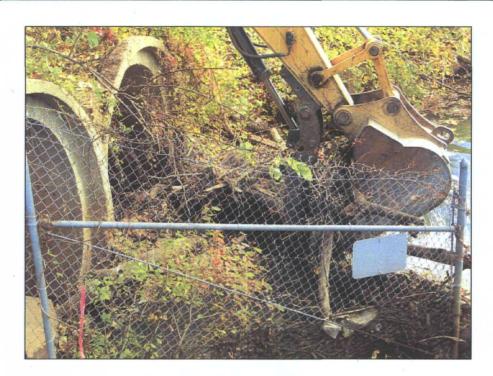
Picture 33: ERRS partially clearing debris from the southern side of the twin culvert (October 22, 2008).

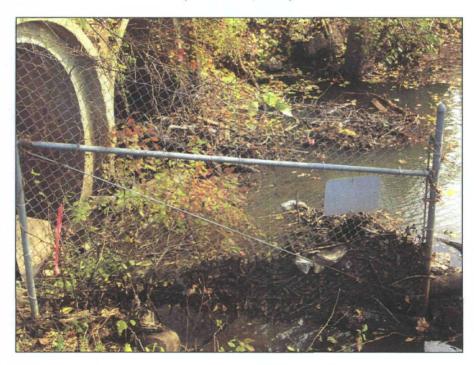
Picture 34: Southern side of the twin culvert with debris partially cleared (October 22, 2008).

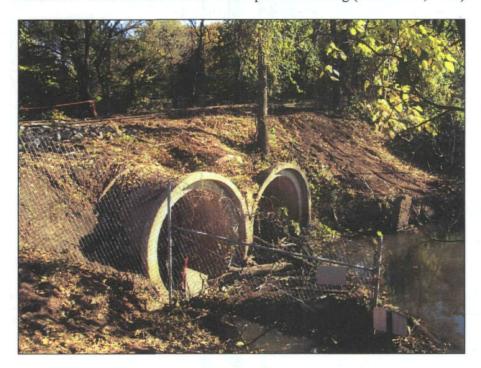
Picture 36: Southern side of the twin culvert cleared. (October 23, 2008).

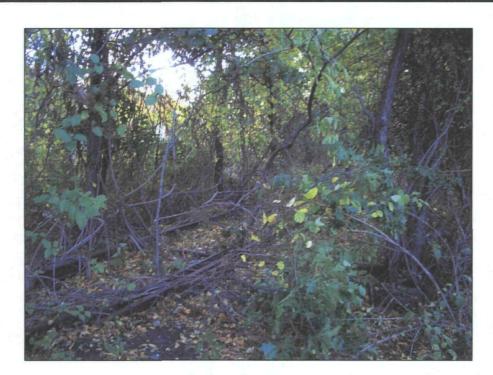
Picture 37: Area above the twin culvert prior to clearing (October 22, 2008).

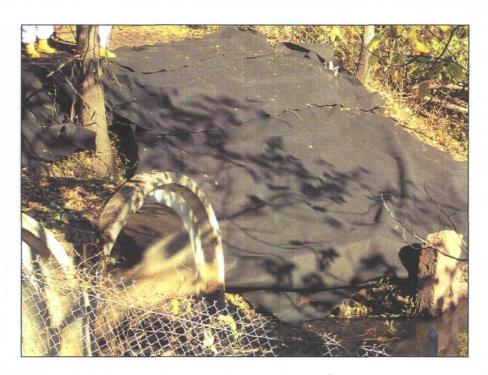
Picture 39: Southern side of the twin culvert with geotextile material installed (October 23, 2008).

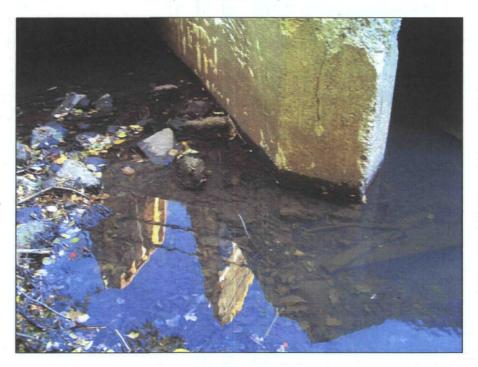
Picture 42: Upstream side of the downstream culvert following clearing (October 22, 2008).

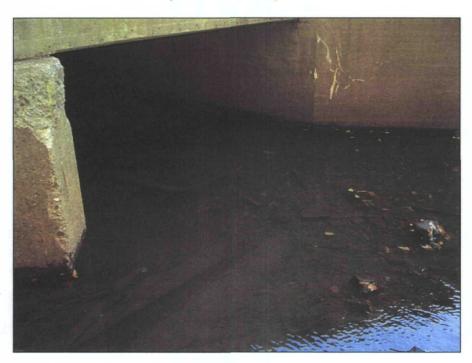
Picture 44: Upstream side of the downstream culvert following clearing (October 22, 2008).

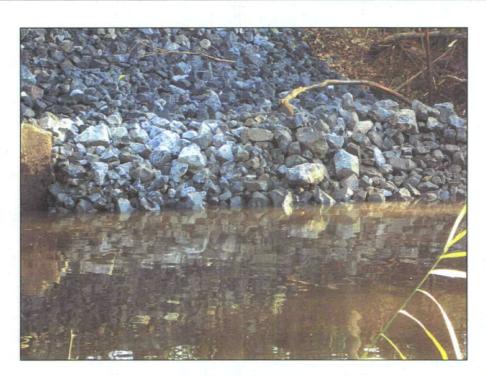
During the installation of Rip-rap, difficulty in transferring stockpiled stone to the work area was encountered. Limited access in the area of the twin culvert and peninsula areas contributed to the difficulty of transferring stone. A 12 cubic foot rock box was utilized to better facilitate the transfer operation (see Attachment 2, photographs 46 and 57).

Picture 46: ERRS utilizing rock box to stage rip-rap for installation on the twin culvert (October 22, 2008).

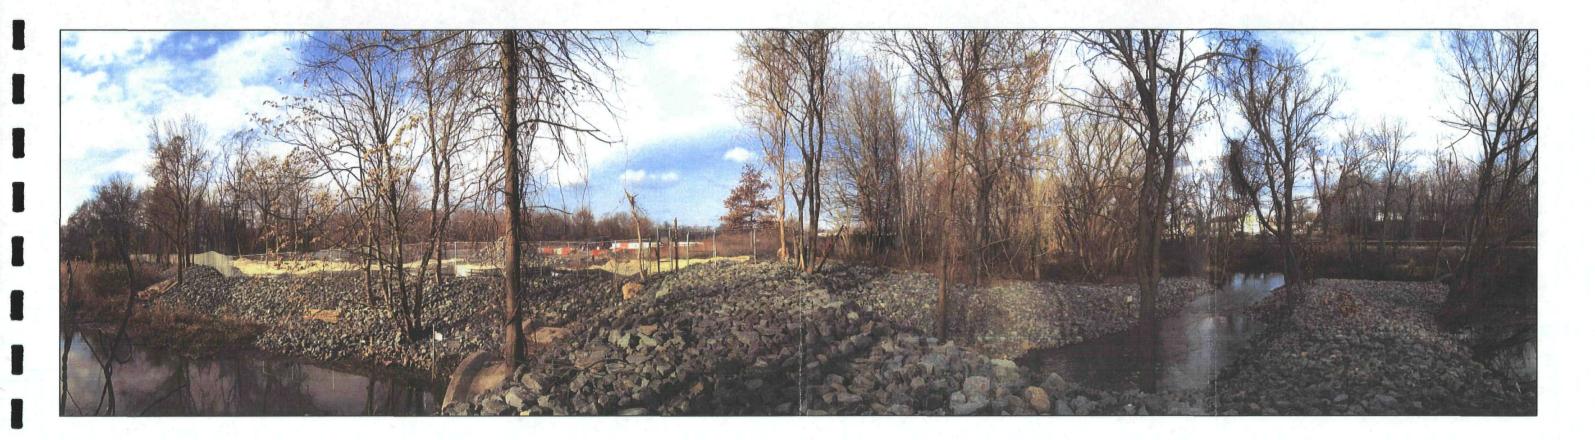
Panoramic View of Completed Construction

- 1. Wetlands area
- 2. Bound Brook upstream of the Twin Culvert
- 3. Rip-rap installed on the Western Bank
- 4. New fence installed at completion of construction
- 5. Rip-rap installed on top of the Twin Culvert
- 6. Rip-rap installed on Western Bank, downstream of the Twin Culvert
- 7. Bound Brook downstream of the Twin Culvert
- 8. Rip-rap installed on the Peninsula

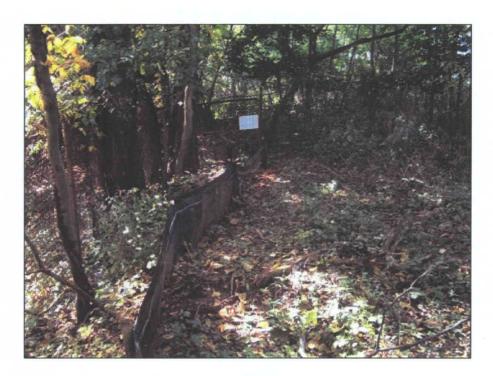
Picture 1: South-eastern corner of Site prior to grubbing (October 14, 2008)

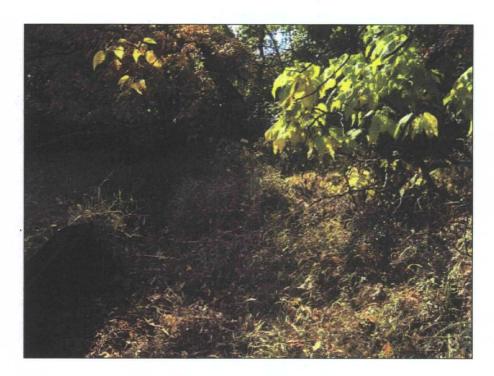
Picture 3: Slope bordering wetland at South-eastern corner of Site prior to grubbing (October 14, 2008)

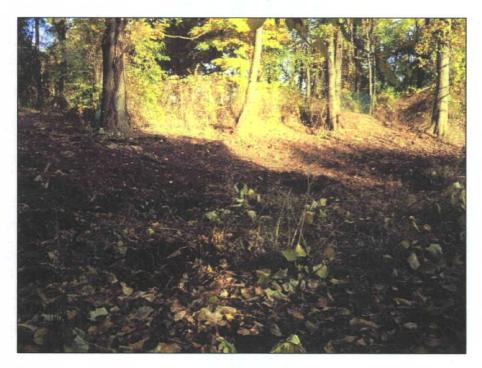
Picture 4: Slope bordering wetland at South-eastern corner of Site following grubbing (October 15, 2008)

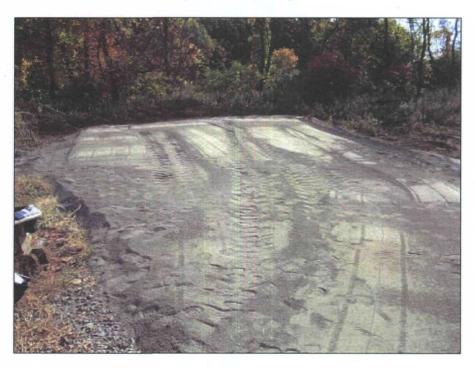
Picture 6: Additional crushed stone placed over poly sheeting in Stone Staging Area (October 15, 2008)

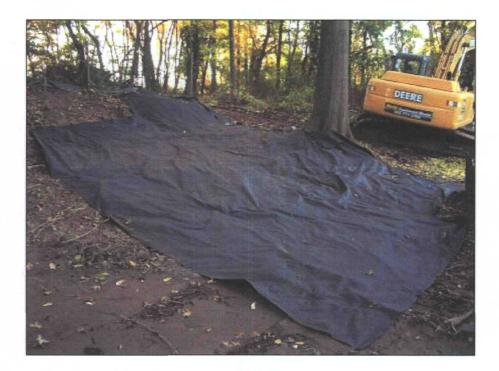
Picture 9: Geotextile material install on bank adjacent to wetland perimeter fence (October 15, 2008)
